The Vegetation Response to Environmental Flows and Restoration Actions in the Colorado River Delta

The Minute 319 Science Team

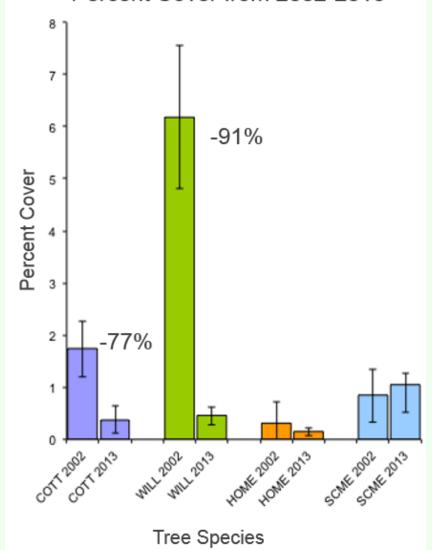
Changes in Riparian Tree Species Percent Cover from 2002-2013

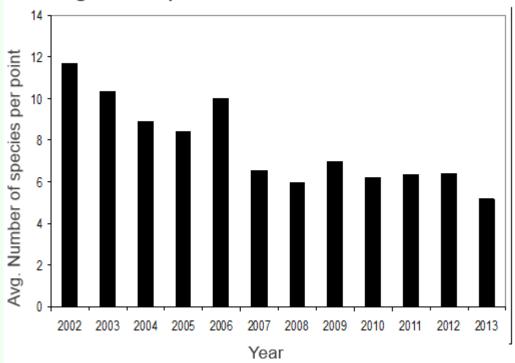
From 2002-2013:

- Avian diversity (N2) decreased 55.8%
- Decrease in percent cover of native tree species

Changes in Riparian Birds from 2002 to 2013

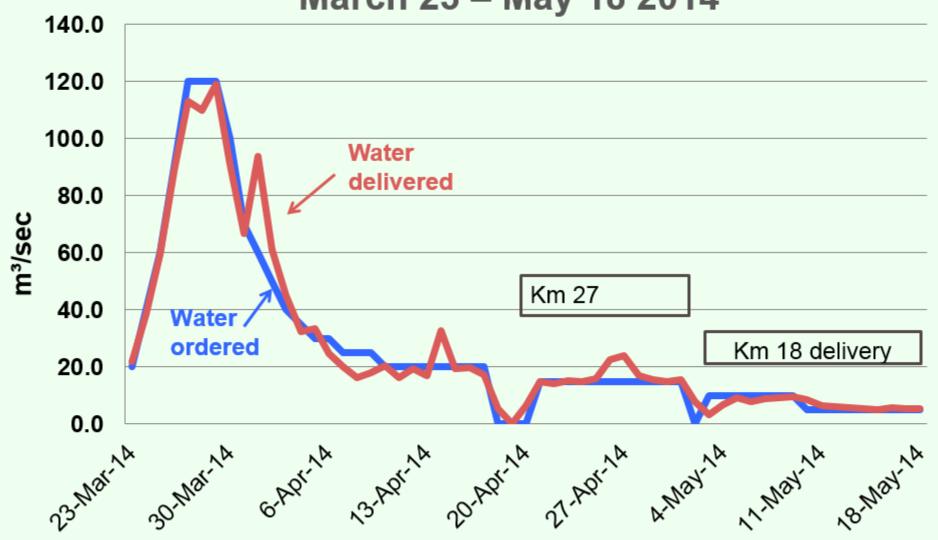
Pulse Flow March 23 – May 18 2014

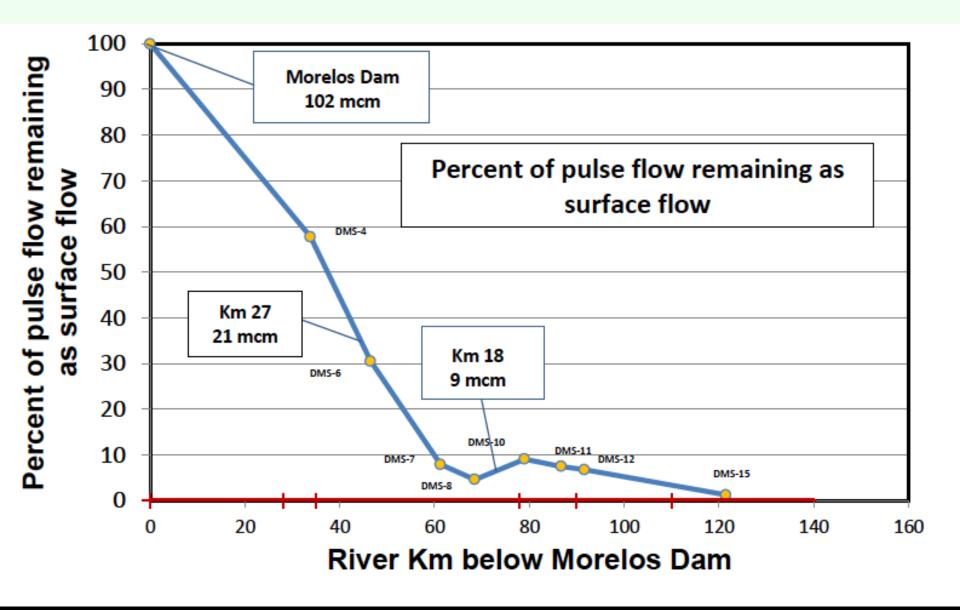
Pulse flow water rapidly soaked into dry river bed

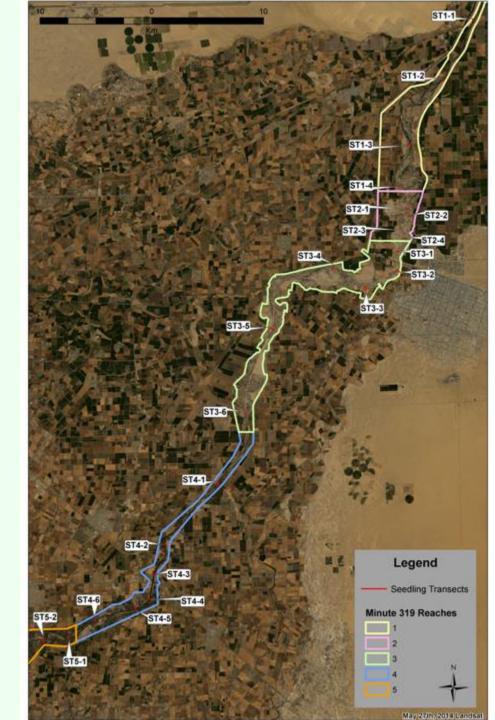
Seedling transects

- Located in Reaches 1-5
- 22 transects co-located with piezometers
- The following was measured:
 - Seed dispersal timing and abundance
 - Pre- and post-pulse vegetation
 - Seedling locations and densities
 - Pre- and post-pulse topography
 - Pre- and post-pulse soil texture and salinity

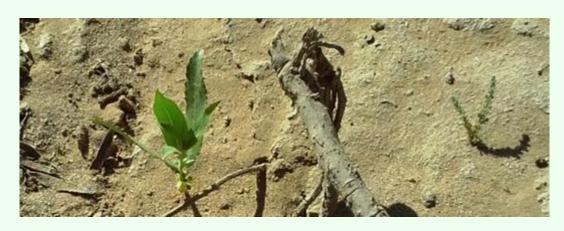
Monitoring "green-up" response

- Normalized Difference Vegetation Index (NDVI) from Landsat 8
- Enhanced Vegetation Index (EVI) from the Moderate Resolution Imaging Spectrometer (MODIS) on the Terra satellite
- Combined these data to document changes in greenness from 2000 to present.

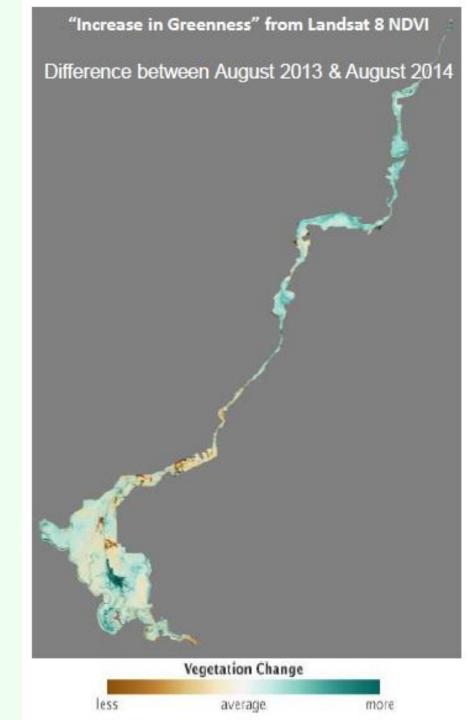
Preliminary Results:

- The 2014 pulse flow increased vegetation greenness and evapotranspiration (ET) in all reaches.
 - Increase in greenness from Aug. 2013 vs. Aug. 2014:
 Inundation zone = 43% Riparian zone = 23%
 - Of total greenness increase, 80% was outside of inundation zone.
 - Annual ET increased: 138 mcm in 2013 to 151 mcm in 2014.
 - The ET increase is equivalent to 10% of pulse flow (13 mcm)
- Vegetation became greener downstream; suggests that groundwater derived from the pulse flowed into the lower reaches and supported existing vegetation.
- *Pulse flow reversed a 13-year decline in vegetation greenness*
